Esperance Culvert Rehabilitation

Assessment Report

South Coast NRM

12 October 2021

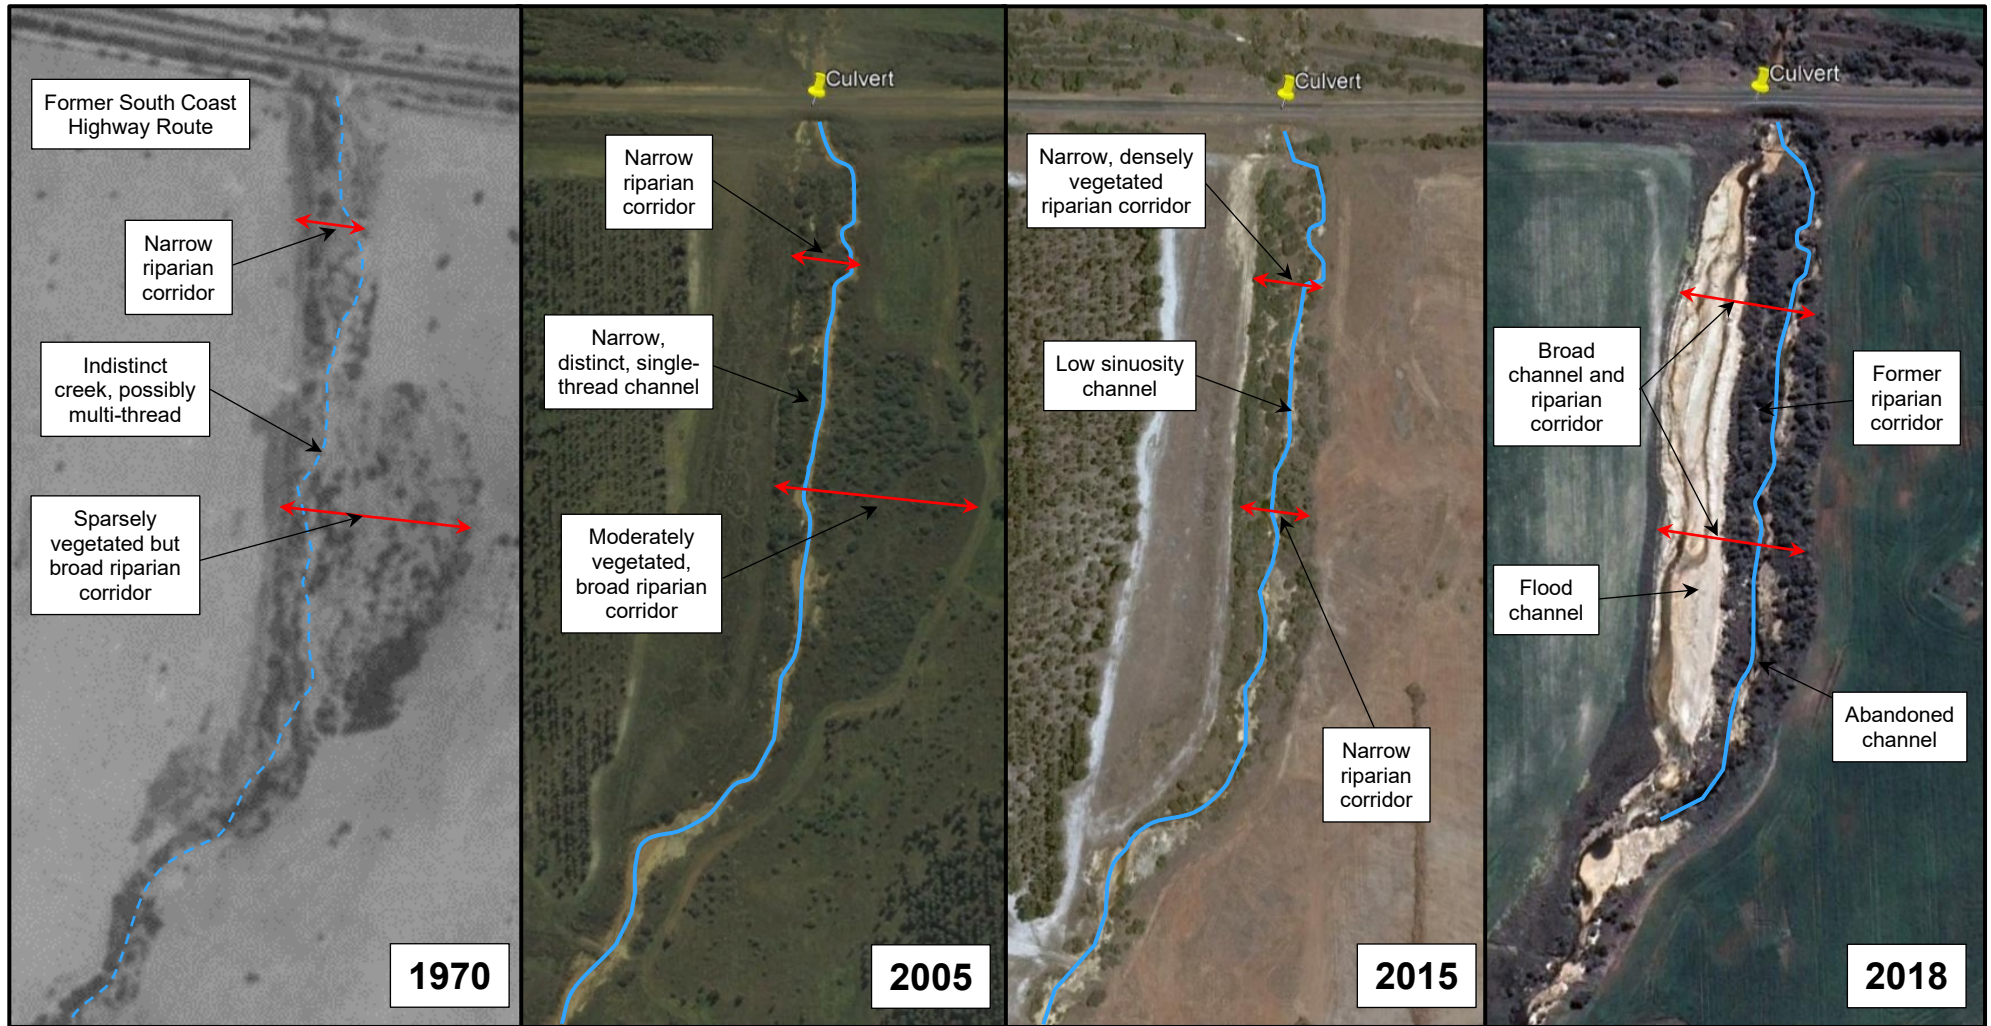
The 1970 image shows that Coobidge Creek had already been heavily modified. The creek flows beneath the South Coast Highway, but the type of flow-conducting structure is not visible. Much of the riparian corridor had been removed during agricultural clearance, although some broader sections of sparse vegetation still remained. The creek itself was indistinct, and may have comprised several smaller channels (multi-thread or braided) in sections. The reaches up and downstream of the study reach also indicate similar characteristics. In some sections, the creek diverged into two or more entirely different channels (known as an anastomosing pattern). Creeks typically evolve multi-thread channels when the sediment inputs are high, for example, as a result of clearance of the protective cover of vegetation.

By 2005, the creek channel had become a distinct, single-thread channel. The riparian corridor is still broad in sections. Vegetation appears to be better established than in the earlier image. Between 1970 and 2005, the South Coast Highway had been realigned, and a new culvert constructed for Coobidge Creek. Downstream of the culvert, the creek bends acutely to the left (east), possibly to occupy a former channel. The planform morphology is unusually straight, indicating that some form of straightening or channelisation may have occurred. There is a possibility that this may have occurred naturally due to the narrowing of the riparian corridor or establishment of more dense riparian vegetation.

The 2015 image indicates that the narrowing of the riparian corridor has continued since 2005, as a result of agricultural encroachment. The creek appears slightly more sinuous, but the channel is still narrow and single thread. This may indicate development of a more naturally sinuous channel following straightening.

The 2017 flood was one of the largest in recorded history, resulting in closure of sections of the South Coast Highway. During this flood, as mentioned in the previous section, the pre-2017 channel of Coobidge Creek was abandoned, and the floodwaters occupied a new channel further west. This new channel is broad, with flows splitting into at least two low-flow channels. The avulsion left the densely vegetated former riparian corridor virtually intact.

Figure 2 Comparison of Coobidge Creek study reach in 1970, 2005, 2015 and 2018 (NOTE: images are not orthorectified, and are not to scale)

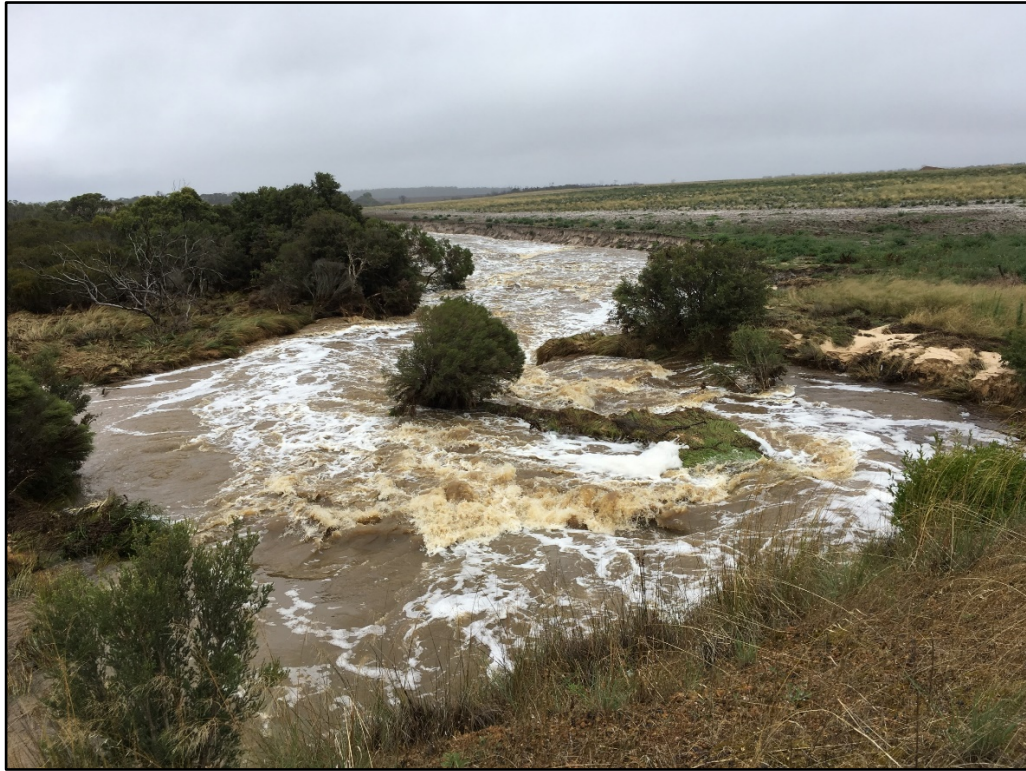
Figure 3 *Coobidge Creek during the 2017 flood, looking downstream into the avulsed channel from the South Coast Highway, with the former alignment within the dense vegetation to the left of the photograph*

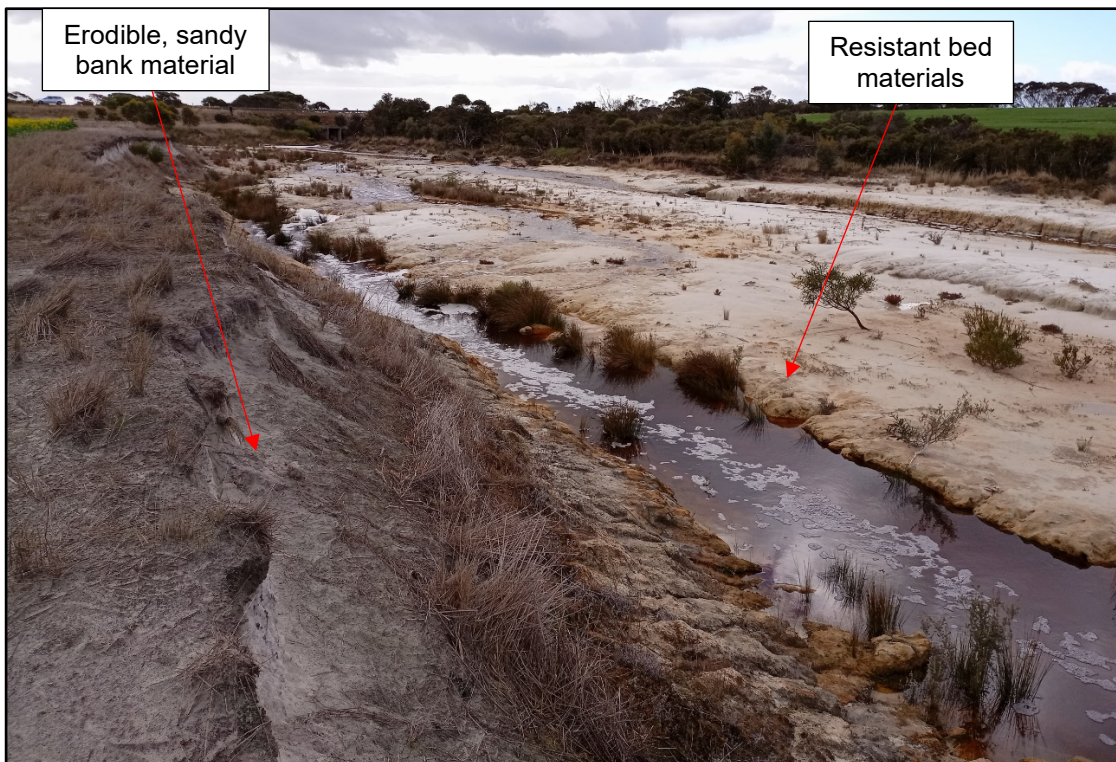
Figure 4 *Post-flood channel of Coobidge Creek after 2017 floods, looking upstream towards the South Coast Highway culvert*

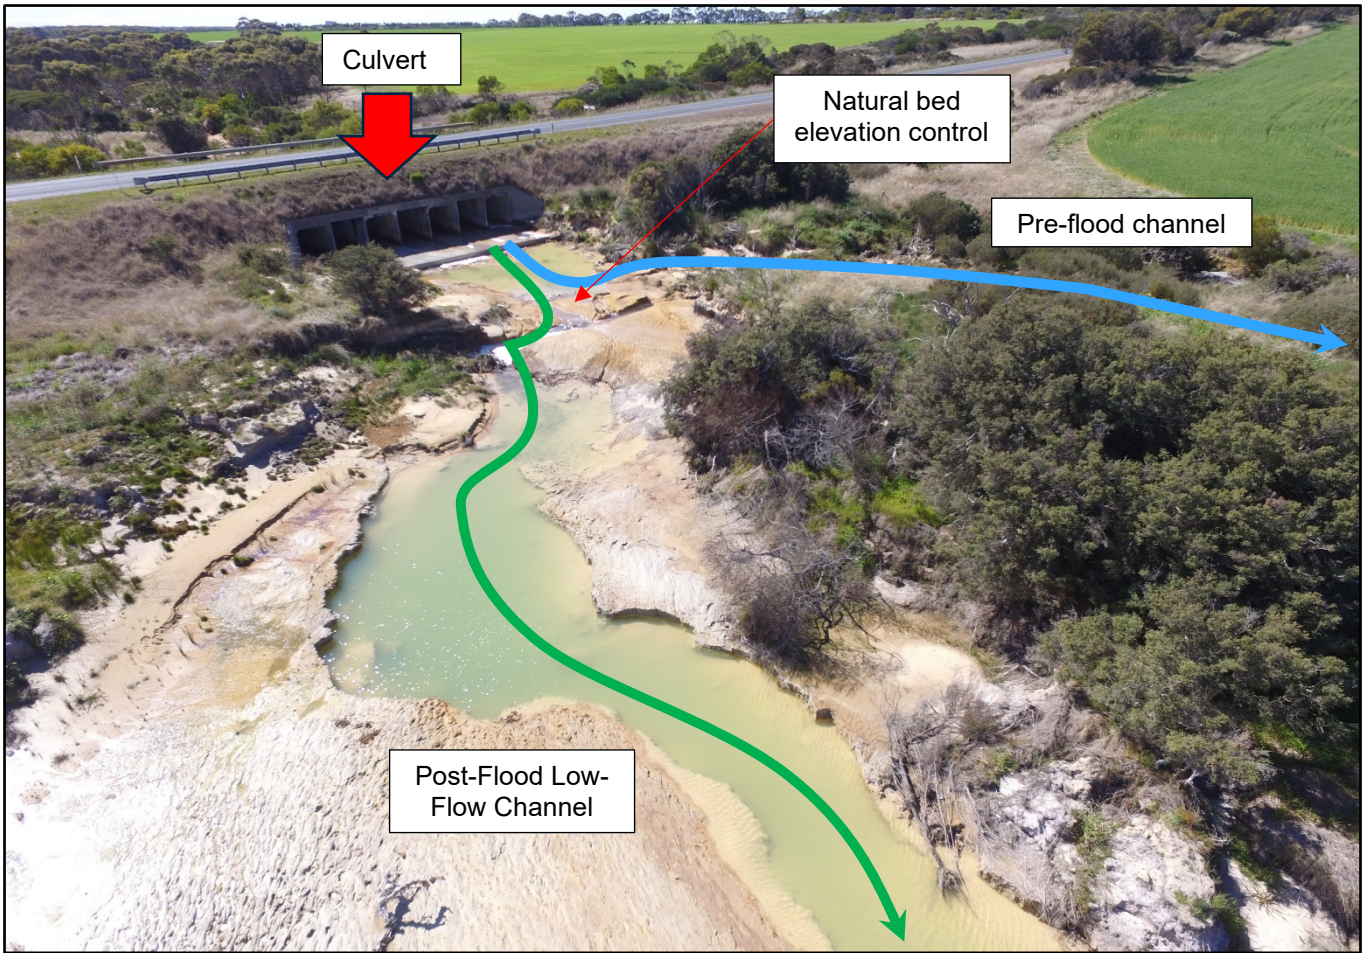
A natural bed elevation control is present just downstream of the culvert (see Figure 5). This appears to have been responsible for diverting the low flow channel to the left prior to the 2017 flood. It is unclear whether this acute bend existed prior to the culvert construction, or developed following construction of the culvert. A deep scour hole formed upstream of the natural control, which is now approx. 0.9 m deep. The scour hole is typical of high velocity flows leaving a concrete lined apron and scouring the relatively more erodible natural bed materials. The avulsed post-flood channel takes an equally acute bend to the right (west) downstream of this natural bed control.

Figure 5 Aerial view of the original and flood channels

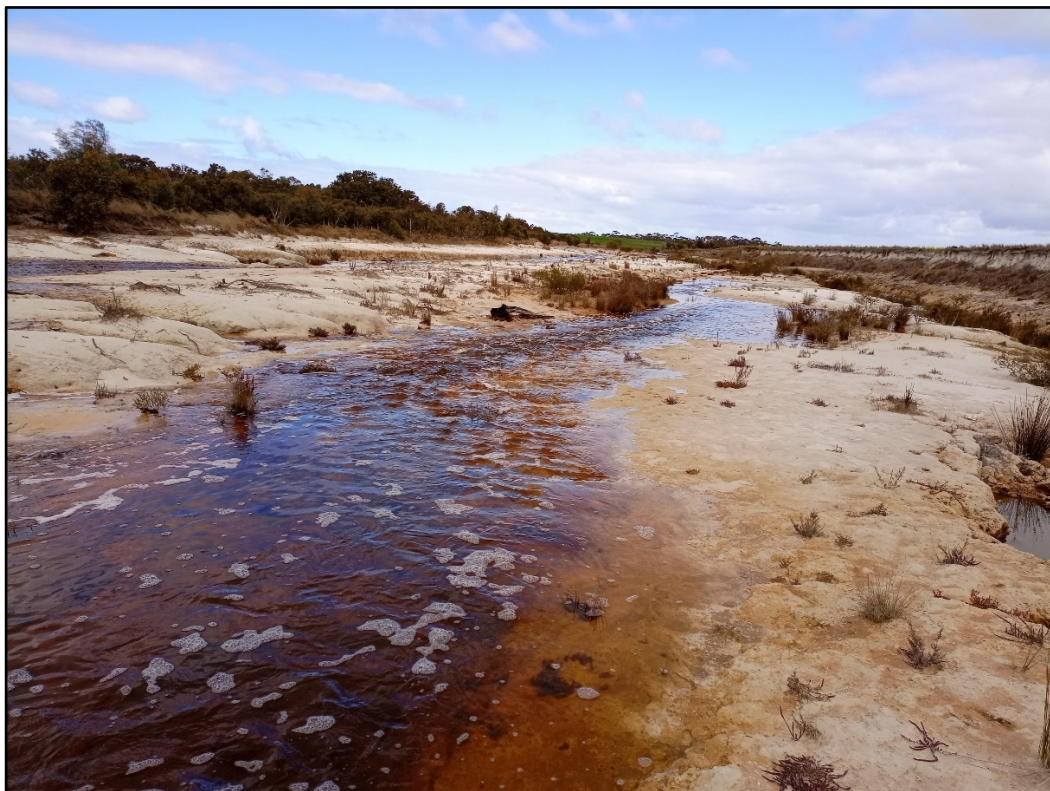
Figure 6 Post-flood avulsion channel in 2021, showing resistant bed elevation controls, multi-channel system and right bank protected by vegetated berm

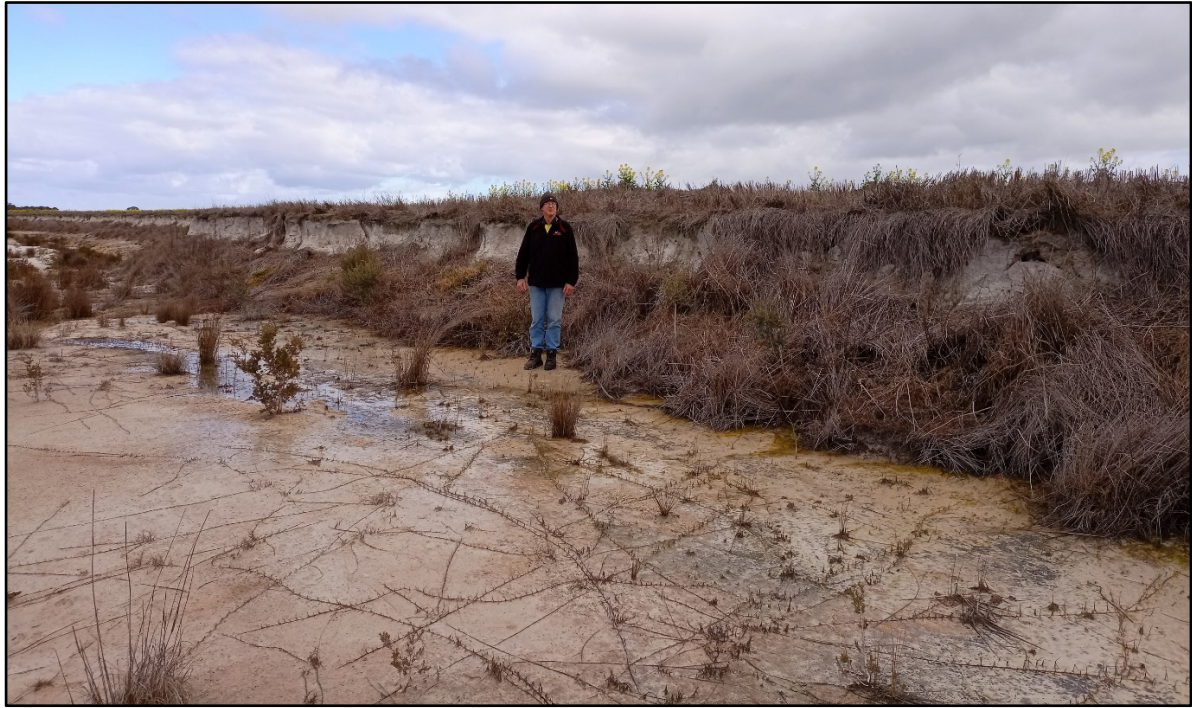
Figure 7 Incised bank of flood channel, with vegetation-stabilised berms protecting right bank. Person is standing on a resistant outcrop perched above the current low-flow channel

- Eroded area over 17,000 m² (Figure 8)
- Depth of soil cover eroded up to 1.7 m (Figure 7)
- Total volume of erosion up to 30,000 m³

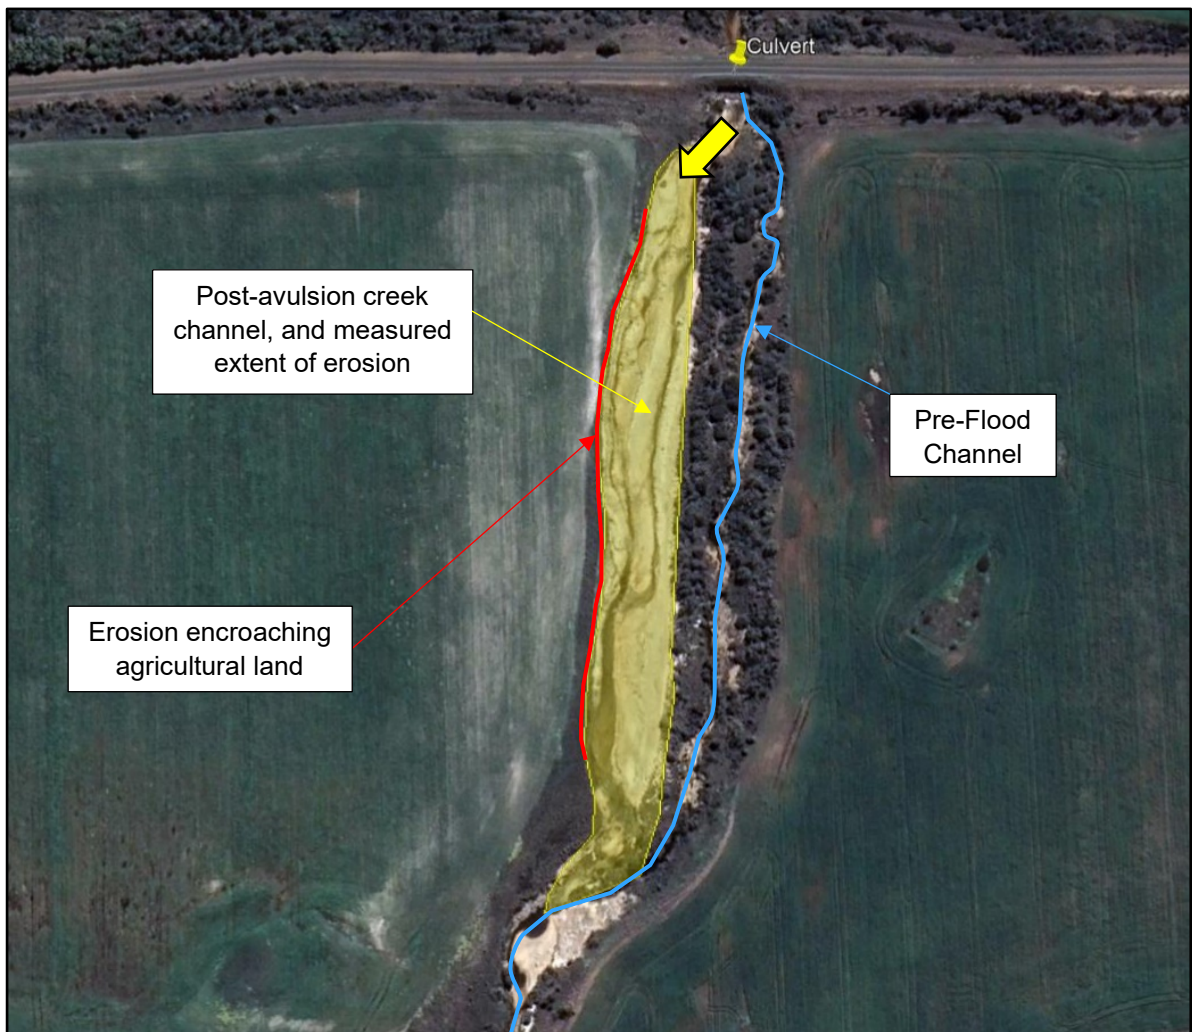
Figure 8 Coobidge Creek avulsion and erosion during and after 2017 flood

To date, more than 17,000 m² of land has been eroded due to the avulsion of Coobidge Creek. The agricultural land buffer has been completely eroded, in some cases, with lateral erosion beginning to encroach worked arable land. The volume of soil lost to erosion is approximated as follows:

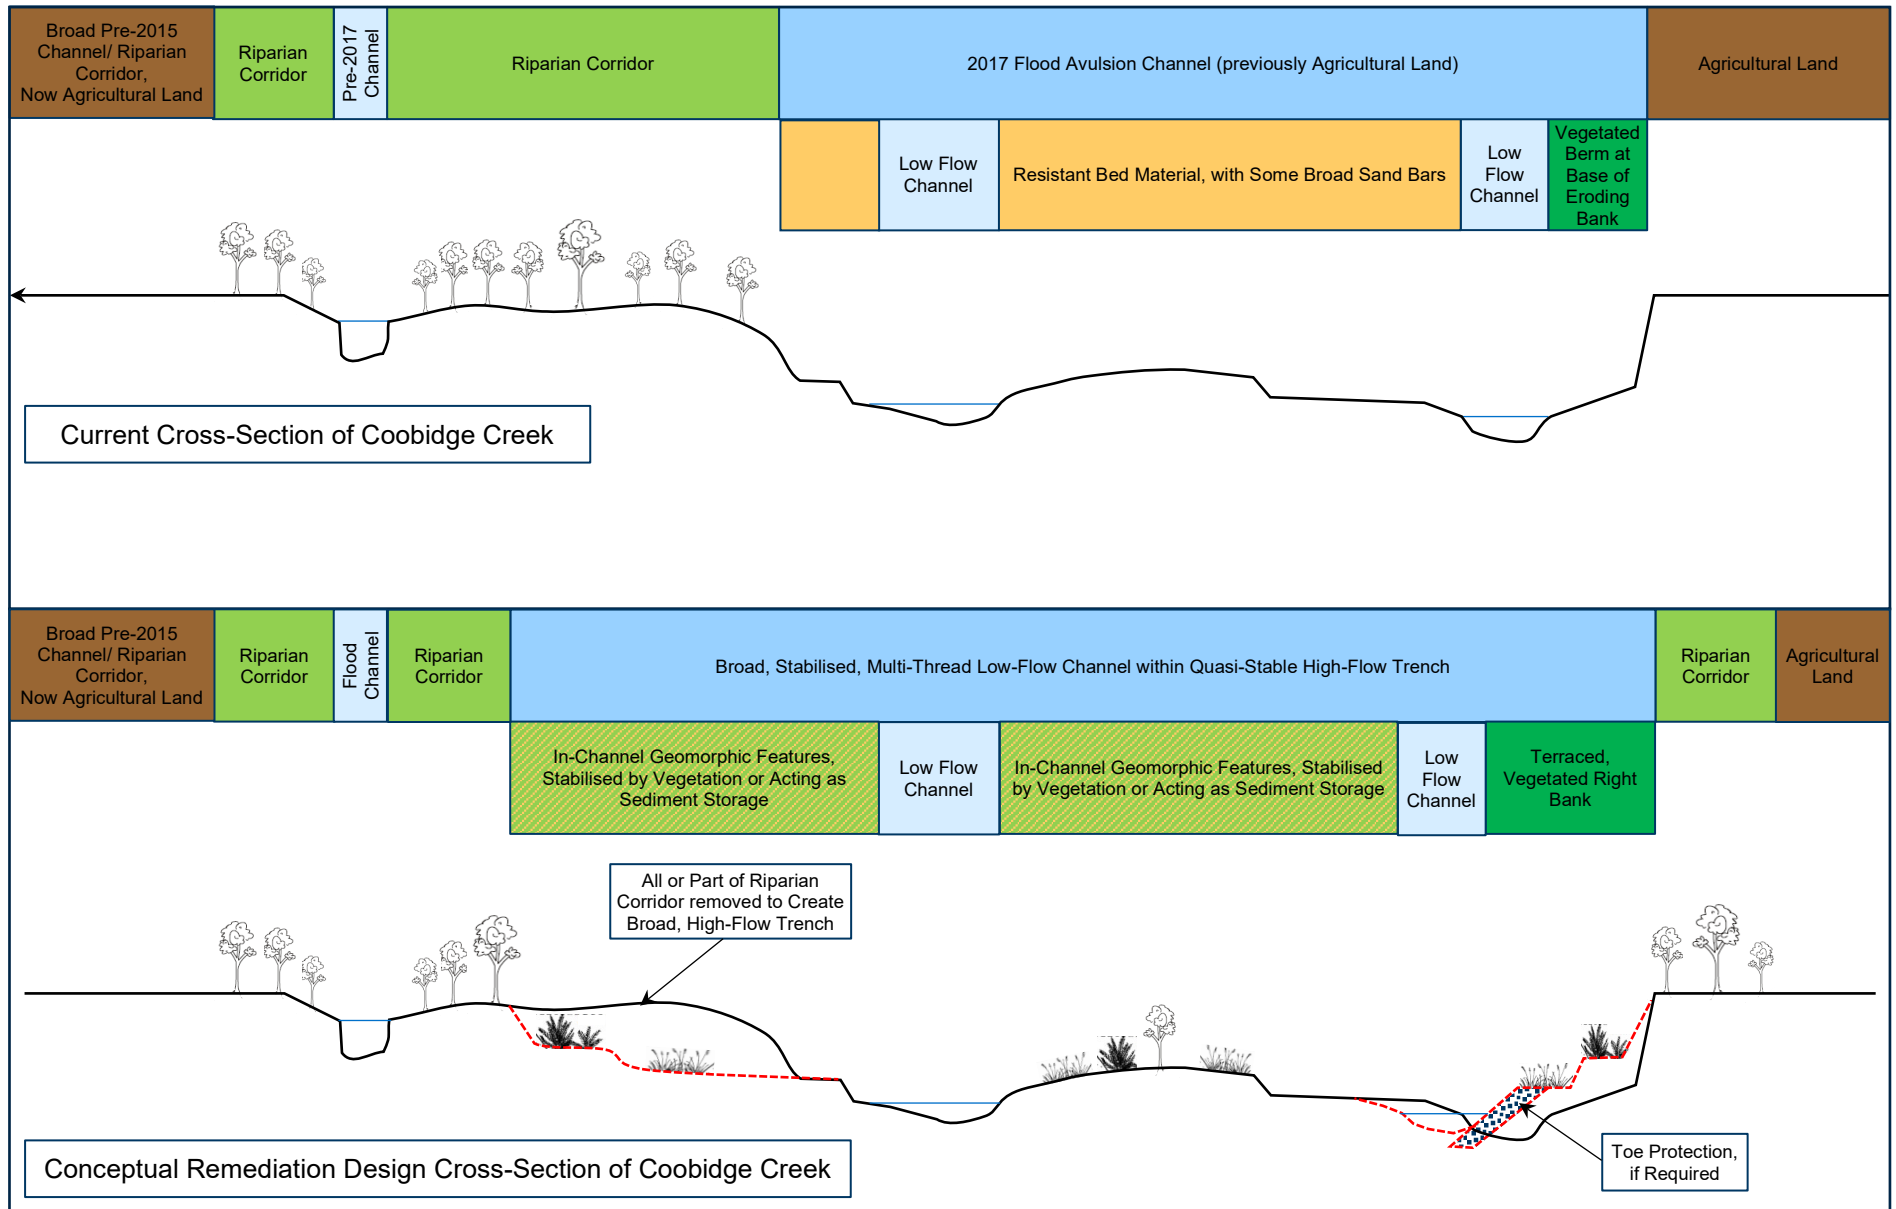
Figure 11 Sketch of current creek morphology and conceptual remediation design
